Repairing & Waterproofing

Below Grade Commercial Freezer Room

Water Infiltration causing Mould & Mildew

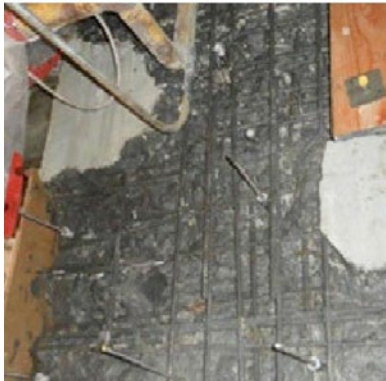
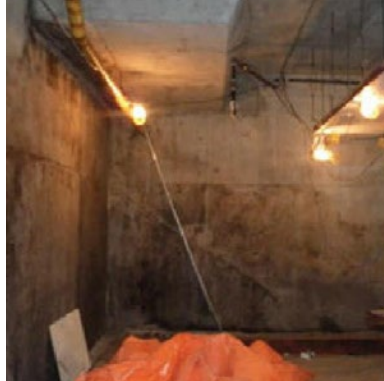
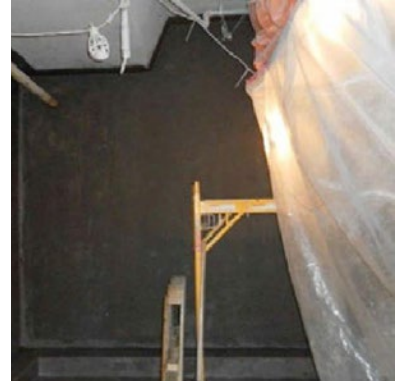
Active leak coming in the basement level of the foundation walls of the produce cooler room causing a significant problem for employees and food storage for a major retail supermarket chain.

- Chase the cracks and sandblast the concrete to open the pores.
- During the prep phase, our team found structural concerns in the concrete. Kelso worked with the consulting engineers to complete the repairs.

- Active leaks were terminated using the CN2000 A (Insta-plug) material.
- Once the new concrete was installed and cured, the CN2000 B/C/D system was applied to the entire area.
- 24 hour cure period once CN2000 C&D was applied and ready for paint
