Canadian Tire

Concrete repair & Waterproofing in Underground Parking Garage

Canadian Tire retail location

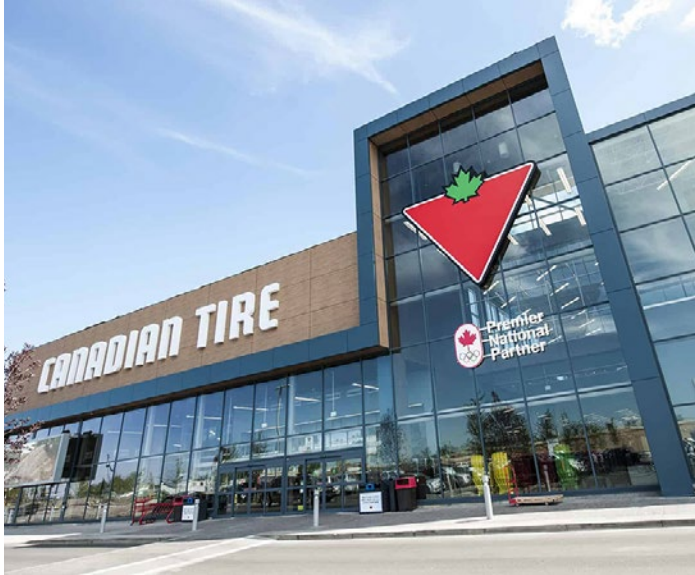
Structural steel beams corroded due to water leakage

- The General Contractor removed the asphalt and the surface was prepared to be coated with CN2000®.
- CN2000® was applied from the outside, which works just as well as applying from the inside.
- After coating and the 24-hour curing period, the area was tested by flooding the surface.
- Once testing confirmed negative leaking results, the General Contractor re-applied the asphalt surface.

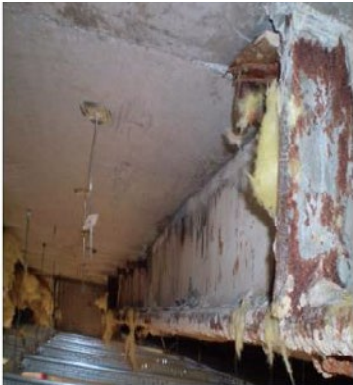
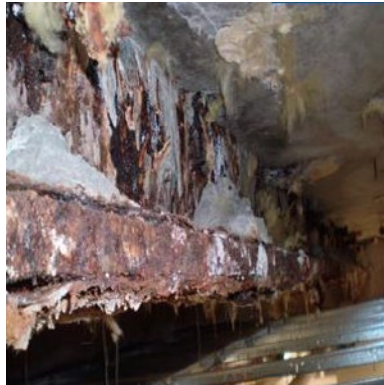
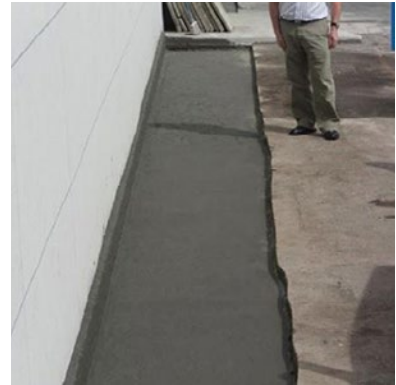
A Canadian Tire retail location with significant leaking in the service department as a result of water leaking in from the overhead parking area.

- Busy retail location.
- Asphalt surface of parking area had to be removed, then replaced once the waterproof coating was in place.
- Existing membrane, which had joints, seams and overlaps, had to be removed then replaced with the seamless CN2000®.

Entire project was completed, and Canadian Tire back to work, within two days.
