Repairing & Waterproofing

Carleton Place

Wastewater Tank Waterproofing

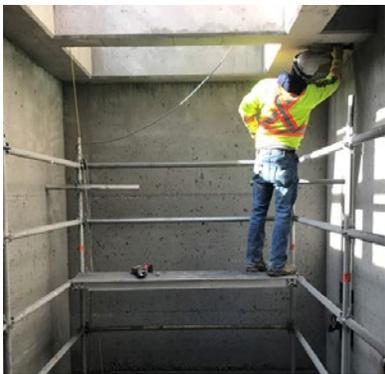
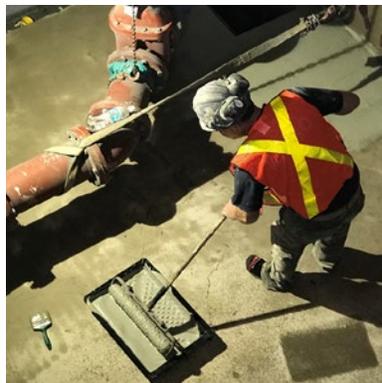
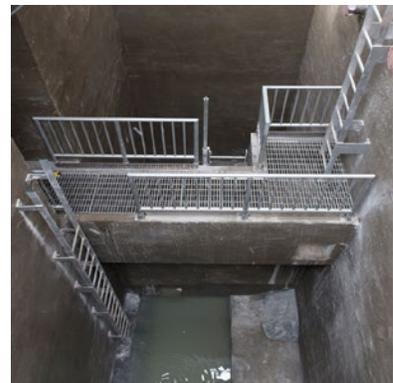
Due to the amount of water infiltration occurring in this structure, it was imperative that our crew of certified applicators identified all the active leaks and terminated them by using CN2000A – insta plug. Once all the leaks were controlled, CR proceeded to wash and saturate the concrete walls and slabs prior to the application of the first coat of CN2000B with a brush. After initial set, a second coat of CN2000B was applied in a perpendicular direction using a trowel. All grooves were filled on this second application making it flush with the existing structure.

For hydration and curing purposes, a single coat of CN2000 C/D (Polymer Modified Cementitious Waterproofing Coating) was applied on top of the CN2000B coating after initial set.

Our certified application crew, CR Stop Leaks mobilized to Ottawa and hired a water blasting company to water blast the walls and slab of the concrete tanks to open the pores of the concrete, which will allow for our activating materials to migrate into the structure. With the matrix of the concrete and the water, CN2000B will produce microscopic "needle like" crystals which will fill the pores, micro-cracks and capillaries naturally existing in concrete to prevent any water infiltration as well as water leaking out of the tank. As long as water is present in the concrete, the activating materials will continue to produce these insoluble crystals but if there is no signs of water, the activating materials will remain in a dormant state until another dose of water re-enters. If for example, a hair line occurs days or even years after the application of CN2000, it will trigger the chemical reaction once again by self-sealing the crack and continue to produce the insoluble crystals preventing any further water infiltration.

Since Health and Safety is Kelso's priority, we hired a licensed scaffold contractor to set up scaffolding in order for us to reach all areas of the tank. Once all the cracks and cold joints were grooved, CR applied the full CN2000 waterproofing system to the interior (positive side) of the waste water tank.

Kelso Coating applied the CN2000 waterproofing system to the entire inside of the wastewater tank (wet and dry side) to protect against water infiltration inside the structure, as well as contaminants exiting the structure. The final leak test revealed that the CN2000 product was successful in completely waterproofing the tank and preventing any signs of leakage.
