Repairing & Waterproofing

Fire and Emergency Services Training Institute

Active water leak into elevator pit

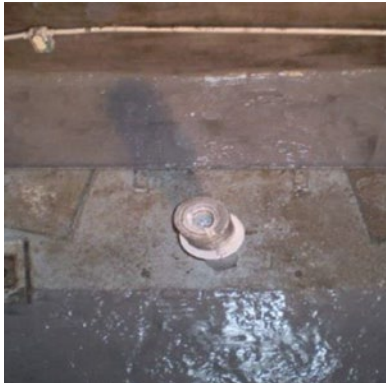
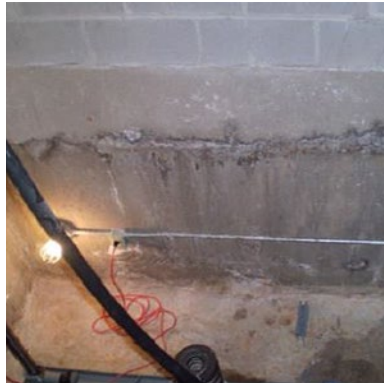
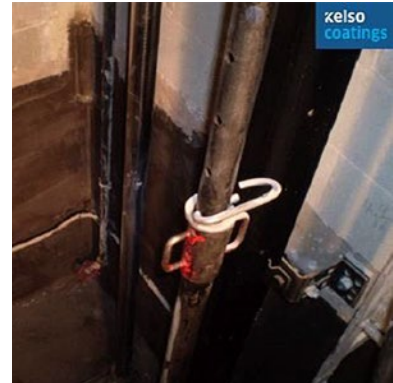
- Cold joint showed visible signs of water infiltration.
- Many flanges, mechanical hydraulics and rails secured to the concrete slab of the elevator pit.

- Kelso Coating's certified applicators u-grooved along the cold joint approximately – 1" in depth in order to pack the CN2000B® material into the groove.
- Two coats of CN2000B® were applied on the exterior walls and floor slab of the elevator pit.
- After the application of CN2000B®, a single coat of CN2000C® and CN2000D® were applied to maintain the hydration required for the CN2000B® to cure according to specifications.
