Concrete repair & Waterproofing

Toronto Pearson Airport

Ground water leakage into Glycol Tank Access Shaft

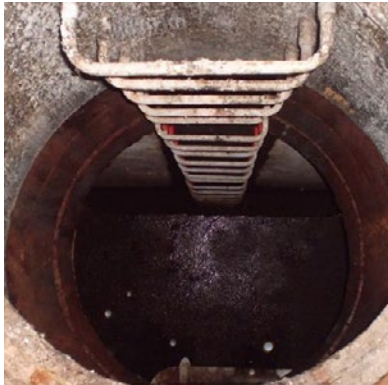
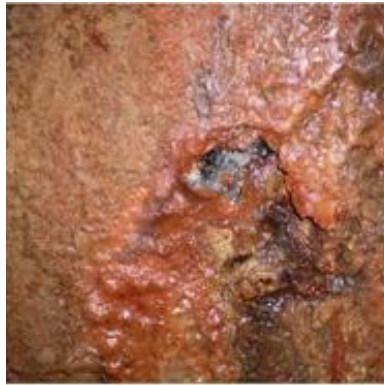
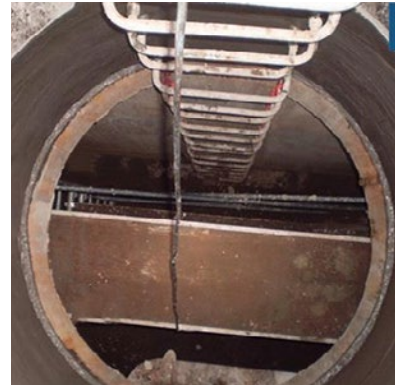
The Greater Toronto Airport Authority sells its recycled glycol for windshield washer fluid. The below grade tanks were experiencing significant ground water leakage because of erosion and cracking in the concrete walls.

- Security clearances required for airport access.
- The contaminants had to be removed from the inner walls of the access shaft.
- Cracked areas had to be mechanically u-grooved and all loose material had to be removed.

- After the surfaces were prepared, CN2000B® waterproofing solution was applied to the voids around the repaired section which molecularly bonded to the concrete and stopped the leaks.
- Two coats of CN2000B® were applied on the inside of the concrete walls to repair the cracks.
- All remaining walls were coated with CN2000B® to prevent any further water infiltration.
- After the application of CN2000B®, a single coat of CN2000C® and CN2000D® were applied to maintain the hydration required for the CN2000B® to cure according to specifications.

After application, the CN2000B® will continue to permeate the base of the concrete by way of its eka-molecular sieve crystalline properties. These patented properties will activate and repair hairline (up to 0.4mm) cracks which may occur in the future from outside pressures.
