Concrete repair & Waterproofing

Toronto Pearson Airport

Below grade water leak in luggage area

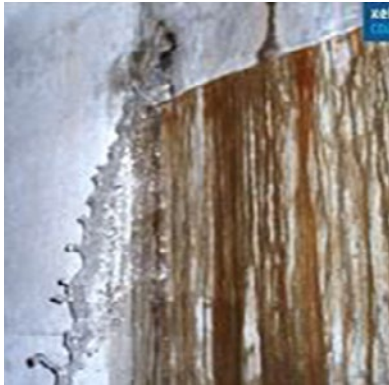
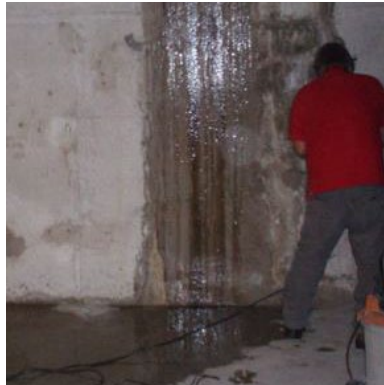
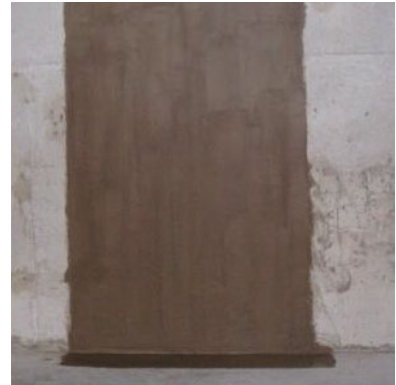
The Greater Toronto Airport Authority had a luggage area that was unusable because of a twelve-year active leak 20 feet below grade.

- Security clearances required for airport access.
- Water infiltration was active.

- CN2000A® was required to act as an insta-plug directly in the cavity of the wall, which swelled and consolidated with the existing substrate.
- After the active flow of water stopped, two coats of CN2000B® were applied to the area of the leak and surrounding area. CN2000B® creates a molecular bond with the concrete and continues to penetrate the structure as long as there is moisture. CN2000B® also contains powerful self-healing compounds to continue to self-repair cracks in the substrate that may form decades after application.
- To speed up the curing process, CN2000C® and CN2000D® were applied to maintain the hydration required for the CN2000B® to cure according to specifications.

The Greater Toronto Airport Authority has the area back to full working use, saving money and allowing the luggage to be stored in the correct location.
