# kelso coatings

Concrete repair & Waterproofing

## Jacques Cartier Bridge

### Hairline cracks in the high performance barrier walls

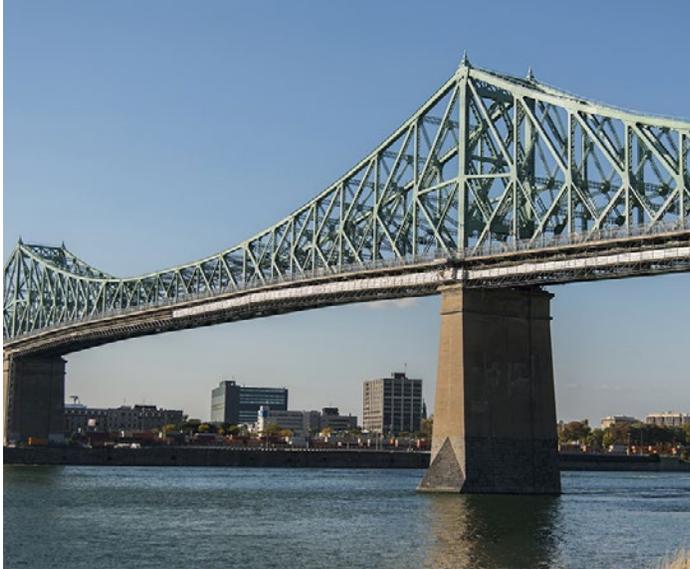
The Jacques Cartier Bridge had developed hairline cracks in the high performance barrier walls which would ultimately lead to corrosion of the reinforcing steel and require replacement of the bridge structure.

- The surface was prepared for the CN2000® coating.
- Two coats of CN2000B® were applied to the wall to prevent any further deterioration and provide a self-healing solution for future cracks.
- After the second coat of CN2000B® set, two coats of the polymer flexible membrane CN2000C® and CN2000D® were applied on top of the CN2000B® coating to provide a labour-free curing process (no mist spraying required), which gives the coating more flexibility to provide protection from vibrations on the bridge deck.

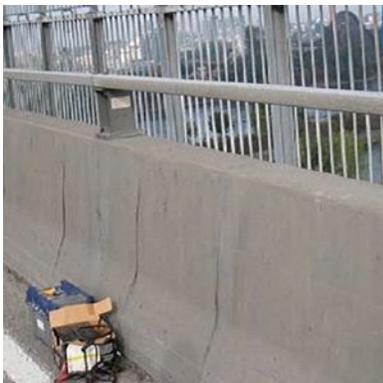
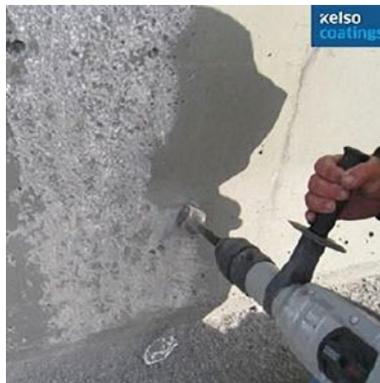
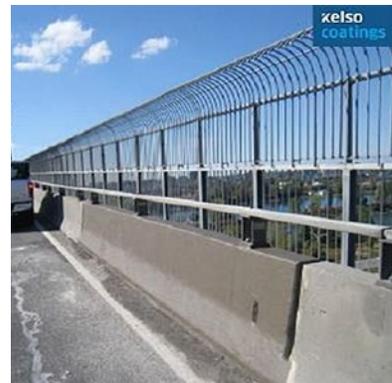
- Busy highway location.
- The sidewalk, walls and bridge deck were all constructed as one piece.
- Cracks would lead to corrosion from chloride ion and freeze/thaw cycles.

CN2000® products are anti-corrosive and will not deteriorate over time. As a result, they will continue to protect the underlying infrastructure from erosion.
