Concrete repair & Waterproofing

Metro Toronto Condo Corporation

Water corrosion in elevator pit

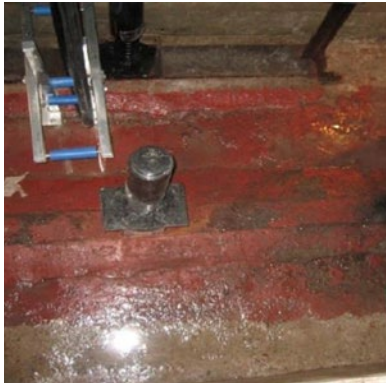
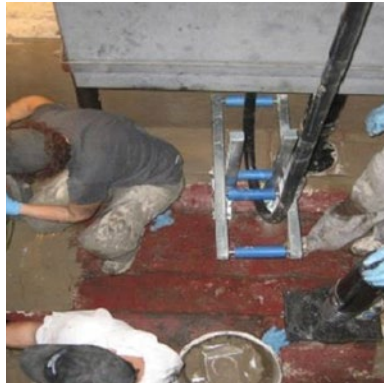
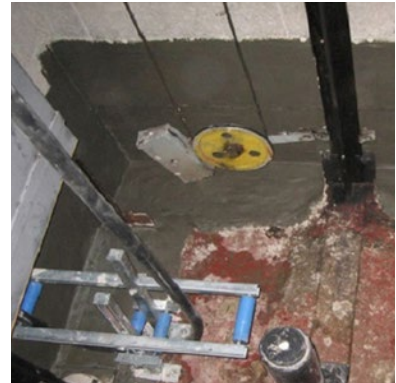
- Cold joint where the concrete slab and walls meet showed visible signs of water infiltration.
- Many flanges, mechanical hydraulics and rails secured to the concrete slab of the elevator pit.

- Kelso Coating's certified applicators u-grooved along the cold joint approximately – 1" in depth in order to pack the CN2000B® material into the groove.
- The surface was prepared by removing the paints, debris and any other contaminants which were visible on the area in need of repair.
- Two coats of CN2000B® were applied on the exterior walls and floor slab of the elevator pit.
- After the application of CN2000B®, a single coat of CN2000C® and CN2000D® were applied to maintain the hydration required for the CN2000B® to cure according to specifications.

There was minimal downtime, the elevator pit no longer leaks and TSSA re-visited the site and signed off on the leak and safety issue resolution.
