Concrete repair & Waterproofing

Midas Auto Service Centre

Active water leak above grade foundation

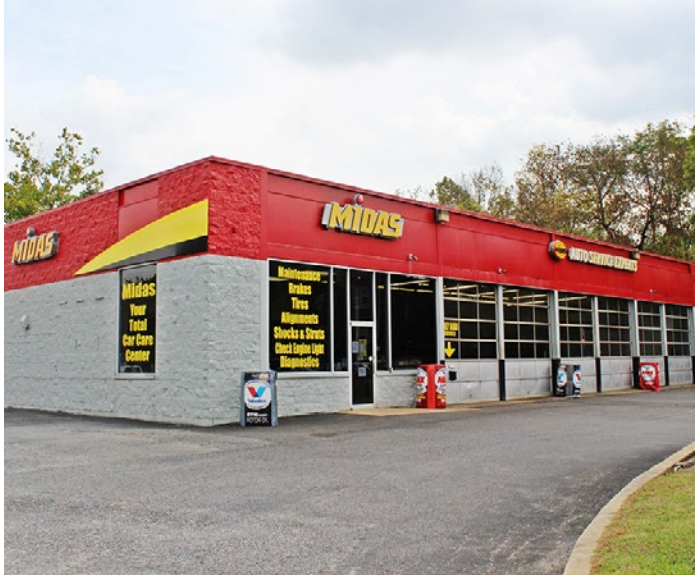
Water was leaking through an above grade foundation wall in hard rain at a busy retail location.

- Busy retail location.
- Previous cementitious parging materials were evident on site however they had not stopped the leaks when rain hit the wall. The loose debris and old cementitious coating had to be removed.

- The surface was prepared for the CN2000® coating.
- The first coat of CN2000B® was applied with a brush and the second coat was applied with a trowel to give a nice looking surface for the subsequent stucco exterior coating.
- After the CN2000® solution was applied and verified for no water penetration, the stucco was applied directly to the CN2000® coating.
