kelso coatings

Repairing & Waterproofing

Museum of Contemporary Art

Foundation Walls, Elevator Pits, Mechanical Room

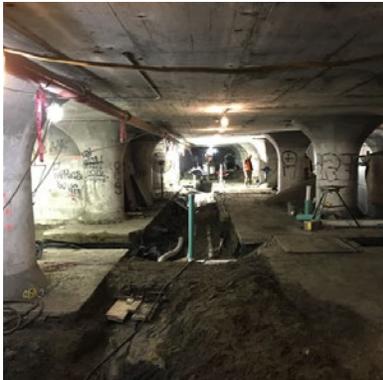
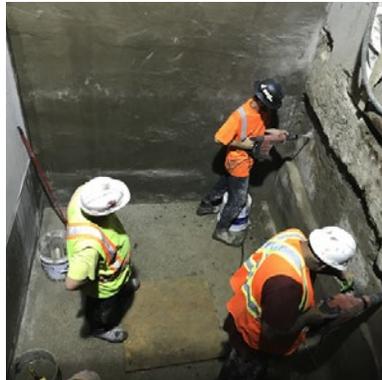
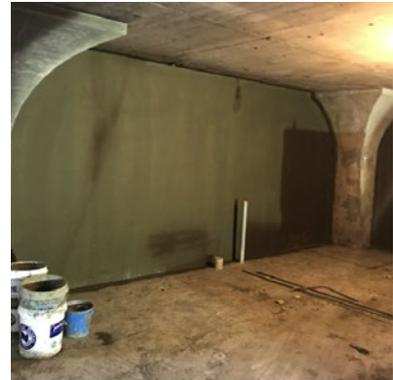
- After controlling water infiltration in the elevator pit, crew prepared the remainder of the pit.
- All cracks and cold joints U-grooved in preparation for CN2000 waterproofing system.
- All cold joints had either an up-turn on the soffit (ceiling) or downturn on the slab.
- All concrete must be washed and saturated with water, prior to application.

- Initial coat of CN2000B crystalline coating was applied on the interior foundation walls.
- During application, there were a couple of active leaks which became visible. This was resolved using our CN2000A insta plug.
- After all leaks were terminated, another coat of the CN2000 crystalline material was applied using a trowel.
- This was completed with a coat of our polymer modified cementitious coating.

The CN2000 waterproofing system was used entirely on the negative side of all foundation walls, existing and new elevator pits, mechanical room and any other area where there was evidence of water infiltration in the space the museum will be occupying. Proven to resist extreme hydrostatic pressure, dry/wet cycles, and corrosion, the CN2000 waterproofing system will seal the concrete structure, while still allowing the concrete to breath and prevent leaks in the future, providing a safe, dry environment for the museum's art and its patrons for many more years. Additionally, Kelso was able to work with other trades in the general area since CN2000 is non toxic, environmentally friendly and allows the contractor to continue their work in order to stay on schedule.
