Repairing & Waterproofing

Oshawa Mall

Repairing & Waterproofing a Fire Exit at Oshawa Mall

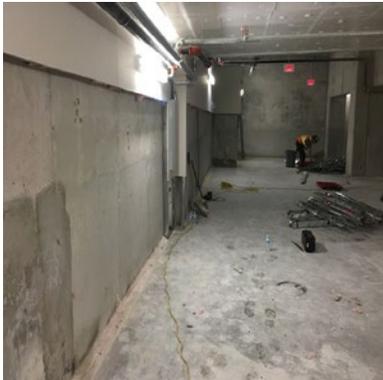
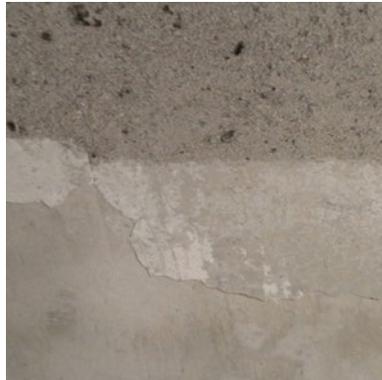
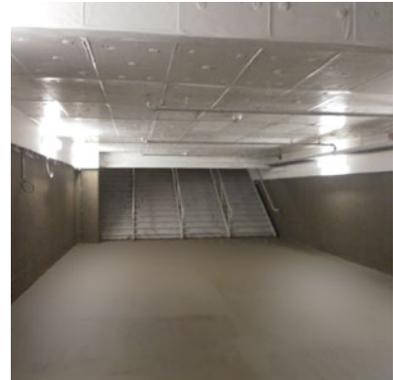
The challenge was that the crystalline coating that was previously specified and applied on the foundation walls in the newly built fire exit had failed. Additionally, the injection method was unable to terminate the leaks occurring. The grand opening was approaching and the owner's were not able to open until the fire exit was 100% dry.

- Remove all dry wall and steel studs to expose the foundation walls.
- Bush tool all areas to remove previously installed crystalline coating and scarify the surface.
- Remove all previously installed injection ports.
- Cut a section of stair well out to have access behind the stairs.
- After terminate all the active leaks with CN200A, HCM applied 2 coats of CN2000B on the interior surface of all foundation walls and kept the CN2000B coating hydrated with CN2000C/D, which is a cementitious polymer membrane.

HCM, who is one of Kelso's certified application crews, along with Kelso, mobilized immediately to remove the previous failed crystalline coating and all injection ports to prepare the surface for the CN2000 waterproofing system. The crew worked around the clock on minimal notice and were successful to terminate all the active leaks and waterproof the entire fire exit (walls and slab) using the CN2000 waterproofing system. The client was impressed with the performance of CN2000 as well as meeting the deadline and budget.
