# kelso coatings

Concrete repair & Waterproofing

### Major leaking in pedestrian tunnel

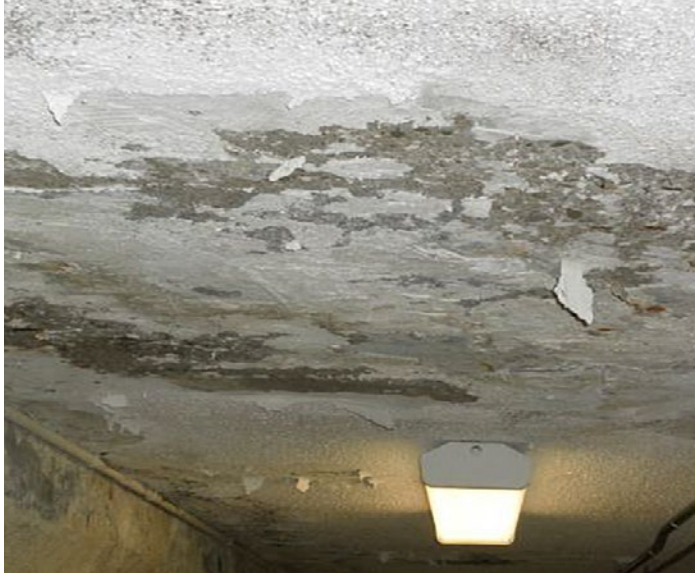
Oxford Properties was experiencing major leaking in the pedestrian tunnel walls and ceiling connecting two multi-residential buildings which resulted in closure of the tunnel for safety reasons.

- Tunnel was unsafe because of water pooling on the floor.
- Paint, loose concrete and all contaminants had to be removed from the interior walls and ceiling of the tunnel.
- Voids were discovered in the foundation walls.

- After the surfaces were prepared, a CN2000® mortar (a mix of CN2000B® and sand) was used to fill the voids in the foundation walls.
- Two coats of CN2000B® were applied on the interior walls and ceiling of the tunnel to repair the cracks.
- After the application of CN2000B®, a single coat of CN2000C® and CN2000D® were applied to maintain the hydration required for the CN2000B® to cure according to specifications.
