North York Station, Toronto, Ontario

Concrete repair & Waterproofing

Toronto Transit Commission Station

Major ceiling leak in electrical room

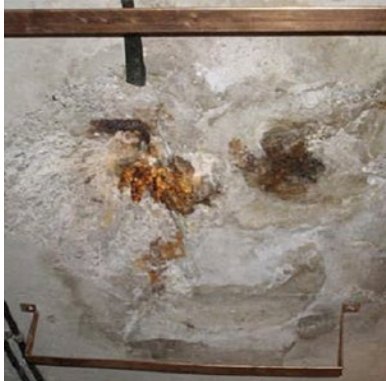
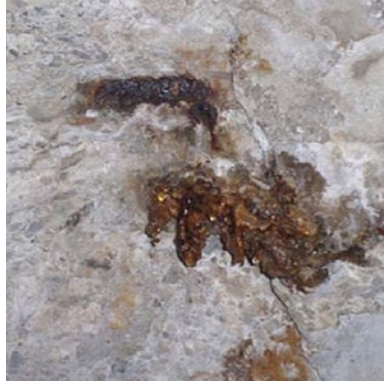
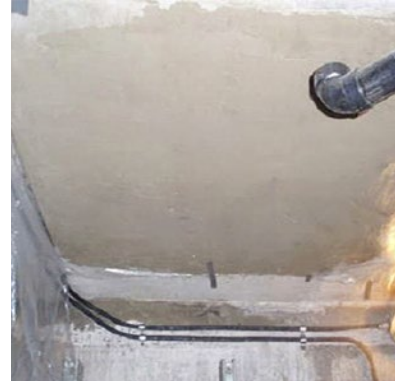
The Toronto Transit Commission was struggling with a major ceiling leak in the electrical room at one of the stations.

- Previous interim solution had been to hang a copper drain pan and pipes, so these required removal.
- Working within confines of electrical room and electrical equipment.

- All surfaces in the electrical room had to be cleaned of all contaminants and prepared for the waterproofing solution application.
- Two coats of CN2000B® were applied on the surfaces within the electrical room.
- After the application of CN2000B®, a single coat of CN2000C® and CN2000D® were applied to maintain the hydration required for the CN2000B® to cure according to specifications.

The Toronto Transit Commission has a permanent solution to the water leak in the electrical room at this station and their union employees were trained by Kelso Coatings staff in the preparation and application of the waterproofing solution.
