Concrete repair & Waterproofing

North York Station

Active water leak into elevator pit

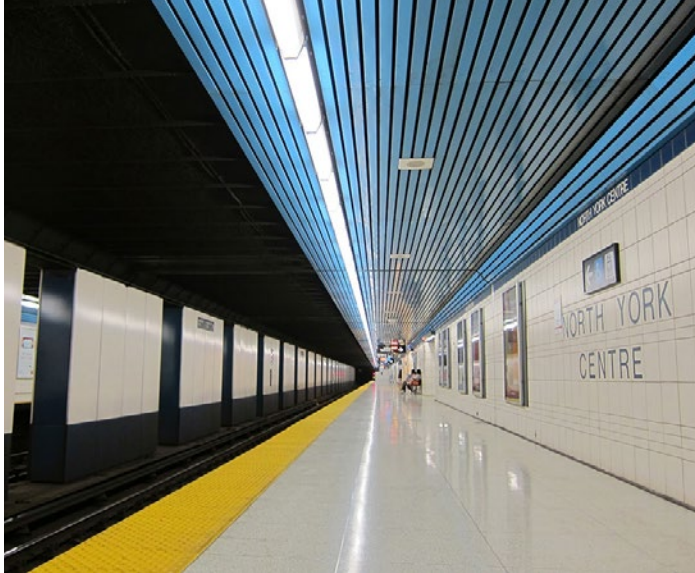
Toronto Transit Commission was experiencing a water leak into the newly constructed elevator pit of the North York Station, one of TTC's busiest stops

- CN2000A® was applied to stop the active water flow.
- Two coats of CN2000B® were applied on the entire wall and floor area of the elevator pit to provide the bonding and self-healing capabilities through its eka-molecular sieve structure.
- Once cured, the CN2000B® coating cannot be punctured so new concrete slabs can be poured directly on top of the CN2000B®. No protection board is required.

The elevator pit is no longer leaking and Toronto Transit Commission union workers are trained and certified in the application of CN2000® products.

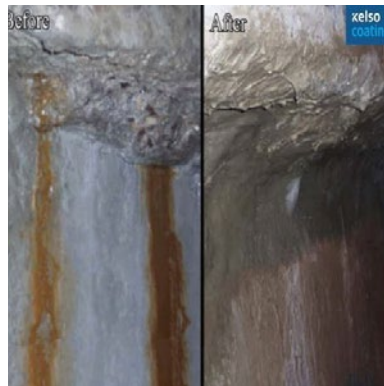
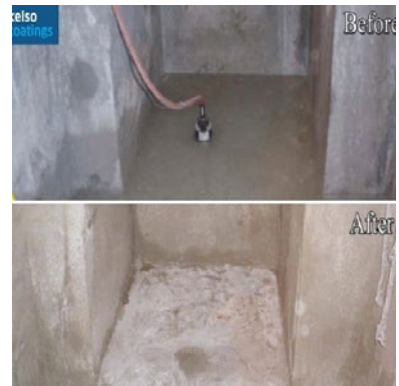
- An active water leak inside the elevator pit.
- The TTC requires union workers to complete maintenance and construction work.

Kelso Coatings trained and certified the union crew to prepare the surface and apply the CN2000® products.

Kelso Coatings oversaw the application and ensured quality standards.
