### **Corrosion, Prevention and Cure to Concrete Sewage Pipes**

### **Research and Development Department**

### **ZHONGHE Waterproof Material Company Limited**

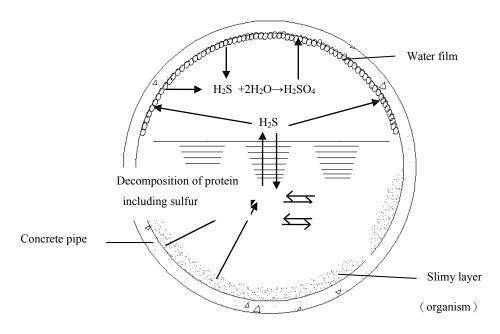
To make the problem simpler and more concentrated, we will discuss it under the mechanism put forward by the Australian, Thistlethwayte, see the following sketch.

Fig 1 the mechanism of erosion of sewage to walls of concrete pipes

The erosion by microbes to concrete pipes is a dynamic process. In fact they are series of complicated biochemical reactions focused on oxidation-reduction under the action of microbes. The suspended substance in sewage and waste water deposit gradually along with the water flow on the bottom of the pipe and become a slimy layer; the organism becomes a nutrient source to microbes; Under oxygen-poor conditions, anaerobe beaks down the organisms and snatches its carbon to form a colorless and flavorless methane, but with organic sulfide the product will become hydrogen sulfide gas. For example, a protein containing cysteine, after decomposition and devulcanization by bacteria will release hydrogen sulfide. The reaction is as follows,

Hydrogen sulfide generated in the above two ways, escapes from the sewage and enters into the pipes air space and contacts the pipe wall, and dissolves in the water film condensed on the wall; while on the wall, the hydrogen sulfide suffers a biochemical action of the aerobes: thio-bacteria oxidizes the hydrogen sulfide and produces sulfur, while thiobacillus oxidizes sulfur and produces sulphuric acid; the reaction is as follows,

Generally speaking, for the inner concrete wall of sewage pipe, below the sewage liquid level, concrete suffers mainly from erosion of the weak acids generated by the metabolism of microbes in the sewage; above the liquid level, in addition to weak acid, concrete also suffers from erosion of hydrogen sulfide and sulfuric acid generated through the microbe oxidation; the biological film at the interface between the air and liquid is the optimum environment for bacteria growth, where microbes breed prolifically

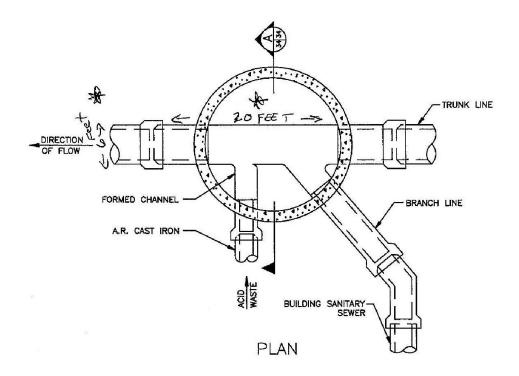
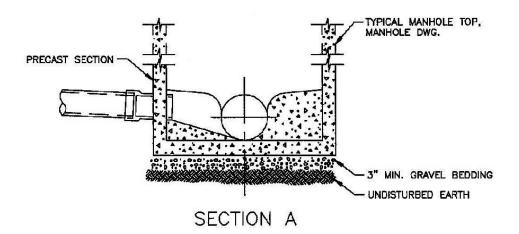
• The pipe sketch:

• Testing area: Diameter 6 ft (1.829 mm); length 20 ft (6.096 mm). The total area of 10 pieces of pipe is 3770 ft<sup>2</sup> (350 m<sup>2</sup>); the 3 ones in 10 pipes have holes.

At the invitation of an America agency, in order to prevent seepage and resist microbe erosion to concrete we plan coating with **CN2000B** on the inner wall of sewage pipes in Florida. The data about the environment and the pipe sketch are as follows.
