City of Burlington

King Rd. Underpass

Repairing & Waterproofing Bridge Abutment Walls

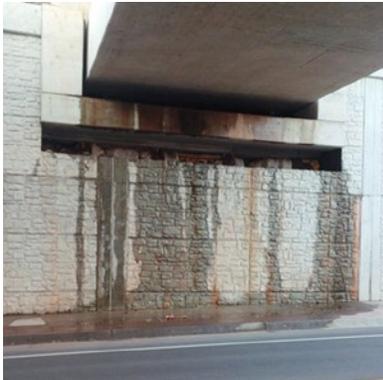
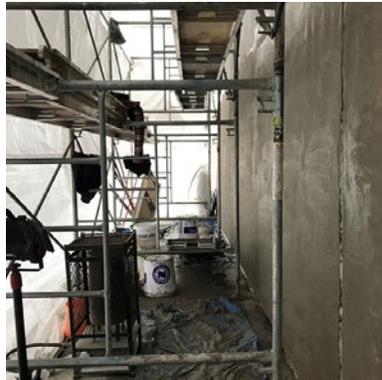
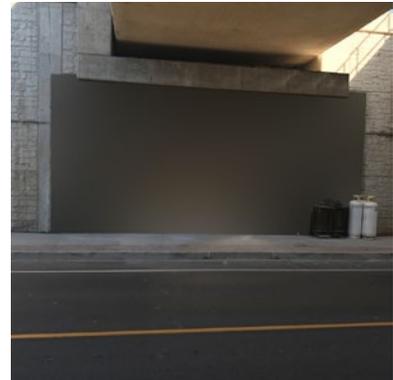
The project in the King Road underpass in Burlington Ont. It's a road underpass of Metrolinx' Lakeshore West rail corridor and Indian Creek (i.e. an aqueduct). The leak is on the upstream (west) abutment wall, and seems to be the effect of having a high water table and a cold joint. Water seepage on the underside of a railroad bridge abutment needed to be treated to preserve the structure's integrity. A secondary bridge is also located at the site to allow for a creek below to flow freely. The primary bridge is used mostly by Canadian Pacific rail, so it was imperative that its strength was upheld to enable the safe crossing of freight trains.

The problem is when the water freezes in the winter, the City of Burlington hires a crew to go to the bridge site periodically and remove the large chunks of ice that has adhered to the abutment walls so that when a thaw occurs, the chunks of ice do not fall on a pedestrian or vehicle.

- Filled in cavities by means of shotcrete - All work was performed on both sides of the bridge structure
- Sand-blasted structures prior to application of CN2000 materials.
- Hoarding and heating was required to maintain temperature of concrete.
- Dufferin supplied concrete for shotcrete phase.
- After shotcrete cured, CN2000 waterproofing system was used as a topical application.

- Wet mix air placed concrete (shotcrete) supplied by Dufferin and installed by CR Stop Leaks.
- Initial coat of CN2000B applied on entire surface including shotcrete.
- Identify active leaks and terminate the leaks using CN2000A insta-plug. After first coat of CN2000B has initially set but still green, apply second coat of CN2000B in a perpendicular direction of first coat.
- For curing purposes, roll on one coat of CN2000 C&D to keep the CN2000B crystalline coating hydrated for the 24 hour curing process.

Kelso Coatings along with Hatch and the City of Burlington decided that the best way to permanently terminate the leaks is to first shotcrete the undersides of the abutments where the leakage is apparent. Once the shotcrete had cured, the CN2000 waterproofing system was installed to both sides of the bridge. This solution successfully stopped all water seepage, extending the bridge's life for the City of Burlington.
