Repairing & Waterproofing

New Housing Development Manholes

Terminating Water Infiltration and Waterproofing in High Water Table Area

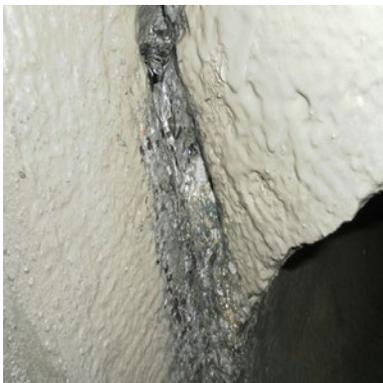
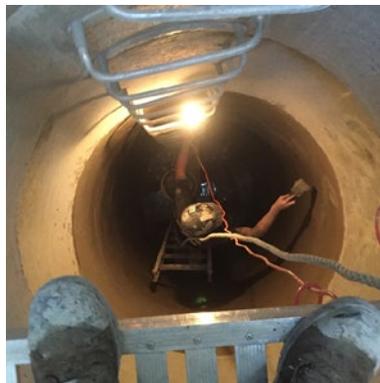
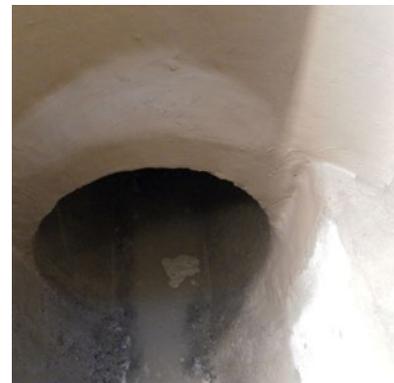
With Greenbelt's assistance, the crew was provided access into the man-holes in question. Some leaks were coming from the joint of the inflow pipe and other areas where the water table was high, the entire interior of the man-hole was treated with the CN2000 waterproofing system. CR had to make sure that they had all the appropriate tools and equipment as the area was being developed, so access to water, hydro, etc...had to be planned in advance.

First thing for Kelso's crew was to identify the amount of hydrostatic pressure in each man-hole and if they should use the CN2000A insta-plug or the EA injection system. They then had to determine if they should pump our CN2000EA macromolecular polymer behind the pipe to stop or at the very least, control the water infiltration in order for us to be able to prepare the joints for our CN2000 crystalline application. Once all active water infiltration was terminated with a combination of the CN2000A and EA, the crew chased the joints and scarified the pipe on both sides of the joints.

In areas where there was a significant amount of water coming through the joints of the man-hole, CR had used our CN2000EA injection (a polymer cement composite grouting material) to control the flow of water in order for them to be able to be able to prepare the joint and apply the CN2000 crystalline system. Once the system had been applied and fully cured, the man-holes that were treated with the proprietary CN2000 crystalline system, will remain leak-free for many more years.

The crew had successfully injected the EA material where required to fill the voids behind the pipe and then used CN2000A insta plug if there was still a little seepage. Once all the leaks were fully terminated, the inner walls of the concrete structure was saturated with water and a brush coat of CN2000B was applied on the area that was prepared. After the first coat reached initial set, a second coat was applied with a trowel. With the trowel application, the applicator filled in all the grooves and made flush with existing structure. After second coat had set but still green, a coat of CN2000C/D was applied on the CN2000B coating to keep it hydrated for the curing process.
