Repairing & Waterproofing

Niagara Falls Casino - VIP Parking Garage

Repairing & Waterproofing Beam in Parking Garage

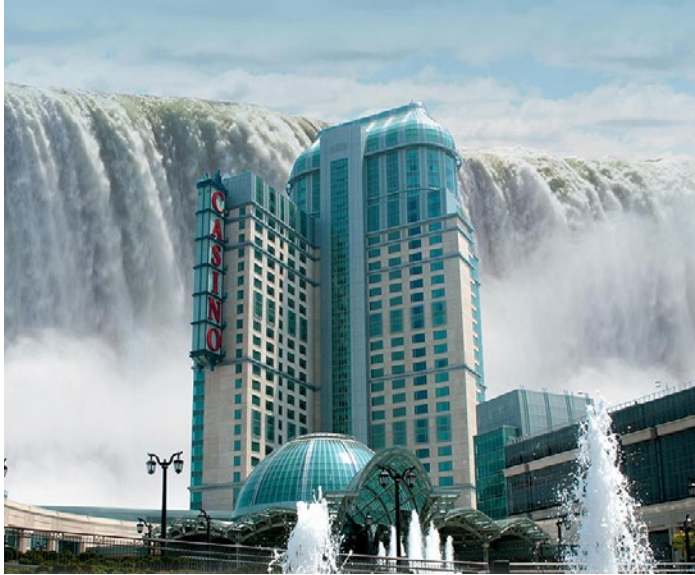
Talk about excitement! Fallsview Casino Resort was built at a cost of \$1 billion and opened to the public on June 10, 2004. The resort remains the largest single investment ever made by the Government of Ontario in the Niagara region. The VIP section in the parking garage had water infiltration issues coming through an overhead concrete beam which was an obvious nuisance for the car owners parking their expensive vehicles in the area. For Fallsview, it was an inconvenience to block these parking stalls and a loss of revenue.

- Hoard off area to be treated with CN2000 waterproofing system.
- Set up scaffolds so that CR is able to prepare the concrete according to technical specifications, which includes chasing of all cracks and cold joints as well as scarifying the concrete structure in a safe manner.

- The full CN2000 system was applied on this project.
- Initially terminating all active leaks with CN2000A.
- Saturate the porous concrete with water and apply 2 coats of CN2000B.
- After initial set, apply 1 coat of CN2000C/D for curing purposes.

Kelso Coatings along with their certified applicators were able to arrest all leaks in the beam by applying our CN2000 waterproofing system to the negative side (inside of structure). All VIP customers can now enjoy parking leak free!
