# kelso coatings

Ontario Power Generation (OPG)

Port Hope, Ontario, Canada

Sewage Pumping Chamber Waterproofing

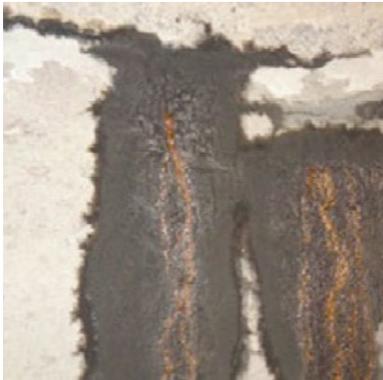
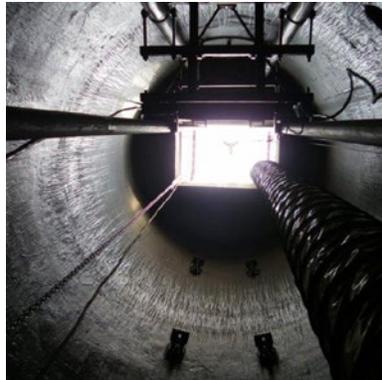
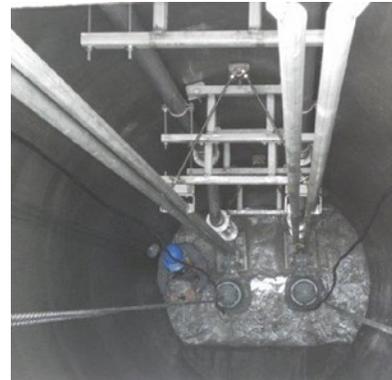
Kelso Coating's CN2000 system was applied to the inside of the manhole's pre-cast concrete joints and cracks exhibited in the pre-cast pipe. Surface preparation was completed by HCM in two days, inclusive of scaffolding, chasing the cracks, and water blasting to open the pores and saturate the concrete to prepare it for application. An additional two days was required for coating application, including CN2000 A (Insta-plug) for active leak areas, two coats of CN2000 B cementitious crystalline, and one coat of CN2000 C and D, a polymer/latex and cement composite applied to add flexibility and cure. Since these materials are resistant to extreme hydrostatic pressure and corrosion, OPG could have full confidence that they would stop water infiltration.

- Surface preparation completed in 2 days. Including chasing the crack, water blasting to open the pores and saturate the concrete.
- Application time of 2 days.
- 24 hour air-dry cure once CN2000 C&D applied.

- CN2000A Insta-plug for the active leak areas. (1 coat)
- CN2000B® cementitious crystalline on the entire area. (2 coats)
- CN2000C & CN2000D a polymer/latex and cement composite applied on the entire area to add flexibility and cure. (1 coat)
