kelso coatings

Concrete repair & Waterproofing in Underground Parking Garage

Parking Garage by Lake Ontario

Concrete Repair & Waterproofing against extreme hydrostatic pressure

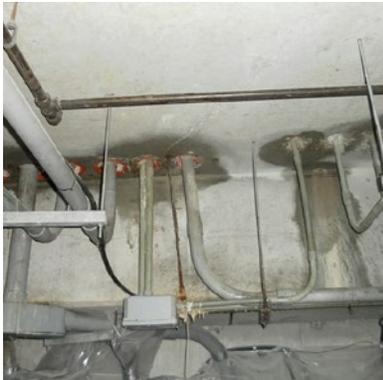
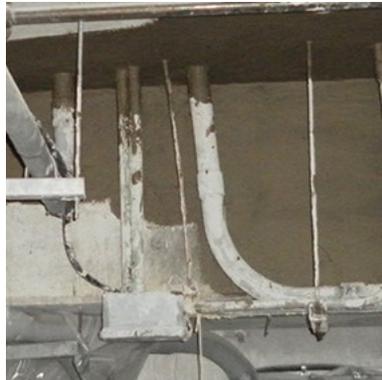
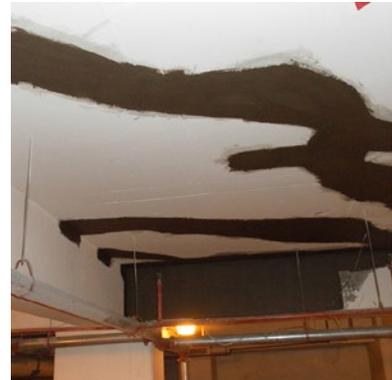
Despite these protective measures, the continuous hydrostatic pressure required the use of a coating designed to perform and protect the garage's soffits. Additionally, the garage was exhibiting cracks and areas of delamination as well as leaks around pipe penetrations and cold joints. The previous solution of injections failed to stop the water infiltration.

In addition to cracks on the soffit and areas of delamination, leaks were evident around the pipe penetrations and the cold joints.

- Surface preparation completed in 4 days. Includes scaffolding, chasing the cracks/cold joints and in this case, sand blasting was used to scarify the concrete to open the pores and saturate the concrete required for application.
- Application time of 5 days.
- 24 hour air-dry cure once CN2000 C&D applied.
- Macdero successfully completed the training and certification process for the CN2000 waterproofing system and can continue the next phase of construction.

- CN2000A Insta-plug for the active leak areas. (1 coat)
- CN2000B cementitious capillary crystalline (2 coats) on areas that were specified by the engineers and prepared and installed by Macdero, who is one of our trained and certified applicators.
- CN2000C & CN2000D a polymer/latex and cement composite applied on top of the CN2000B coating to add flexibility and cure. (1 coat)

CN2000 was also used to coat the exposed steel rebar to act as an anti-corrosion solution to the steel. This application was approved after the Queen's University test results were received and approved.
