Renfrew Hydro Inc.

Repairing & Waterproofing

Renfrew Hydro - Tunnel Below Dam

Repairing Leaks & Waterproofing against hydrostatic pressure

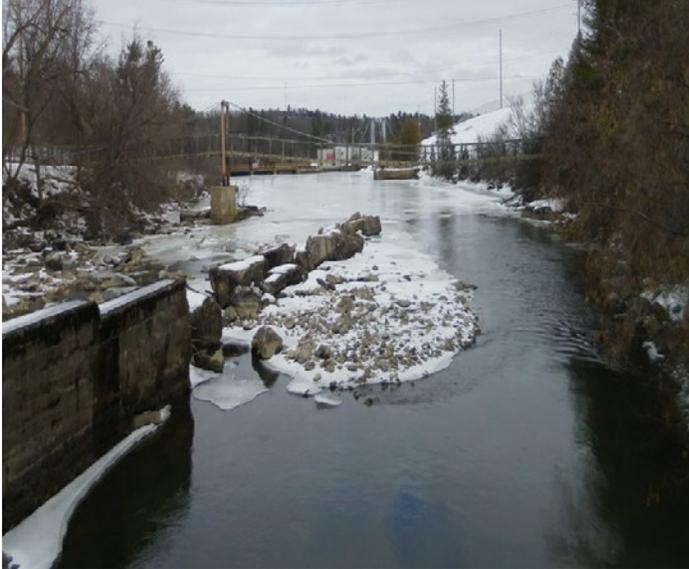
Due to its age, the dam's concrete was in poor condition. The constant freeze/thaw experienced in Renfrew's climate, along with hydrostatic pressures, resulted in many cracks in the dam's walls that needed to be addressed as quickly as possible.

- Remove all previously installed injection ports
- Scarify internal concrete using bushing tool.
- Chase all cracks and cold joints.
- Terminate active leaks using CN2000A
- Apply the CN2000 crystalline waterproofing system.

Kelso Coating was able to stop active leaks in the dam with the CN2000A material, and ensured a watertight seal with the remainder of the CN2000 system. During the preparation of the dam walls and soffit affected by deterioration, many cracks began to leak more than initially and in a couple of instances, Kelso experienced a "gusher". Water pressure was equivalent to a fire hydrant at these areas. The non-toxic CN2000 system resists extreme freeze/thaw cycles, thus ensuring that the dam will operate safely for many years to come.
