Repairing & Waterproofing

TD Place

Underground Parking Garage

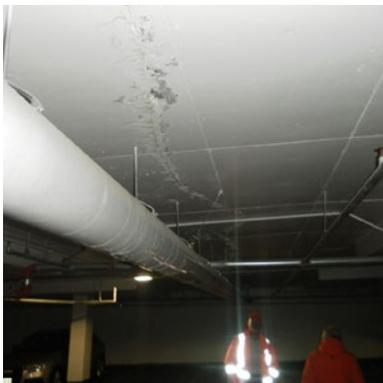
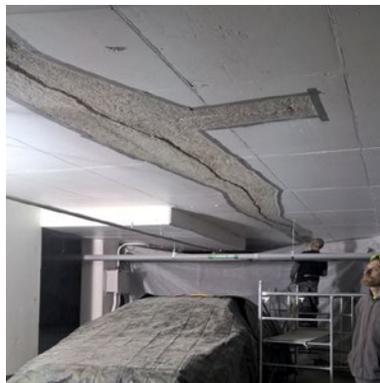
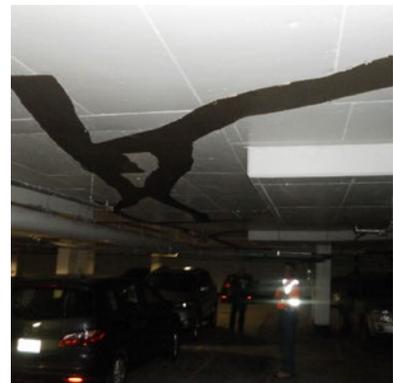
Due to ongoing leaks in the stadium's soffit, the parking structure was beginning to show visual signs of water infiltration. The issue to excavate was the cost as well as on-going events that would have to be re-scheduled. Kelso Coatings was retained to mitigate the leaks and prevent water from entering the garage.

- As in all cases, after all cracks and cold joints had been chased and the concrete scarified by means of a bushing tool according to the property managers request, the certified applicators stopped all active leaks using our CN2000A insta-plug system.

- The first coat of the CN2000B was applied by brush.
- After initial set but still green, the second coat of CN2000B was applied on top of the first coat using a trowel in a perpendicular direction. In order to keep our crystalline coating hydrated, CR Stop Leaks applied one coat of CN2000C & D. This polymer modified cementitious coating will allow the CN2000B coating to remain hydrated and able the chemical reaction to occur with the activating materials in CN2000B, the matrix of the concrete and water. This triggers a chemical reaction producing insoluble (microscopic) crystals, which will fill in the naturally existing pores and micro-cracks in the concrete.

Kelso Coating's CN2000 crystalline waterproofing system was applied to the underside of the stadium's soffits and foundation walls. The CN2000 system was chosen as the stadium's solution due to its ability to plug and stop active water leaks and seal leaking joints and cracks. This CN2000 waterproofing system saved the client a significant amount of money and time with no disruption to their on-going events.
